Cathedral City, California Vertical Control Network

CONTROL SURVEY MONUMENT RECOVERY

Cathedral City

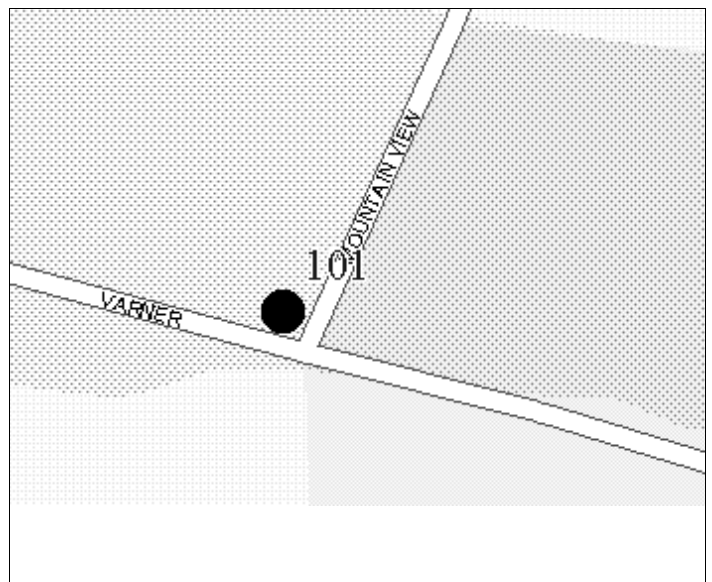
Number: **101**

Monument Description: GPS Useable: Yes
Set Cathedral City bronze disk in concrete monument
Stamping: 101 1996
Center Mark: Punch mark
Recovery By: RBF **Date:** Nov 1996

At the northerly corner of the intersection of Mt. View Rd and Varner Rd

Approximately 20 ft from edges of pavement

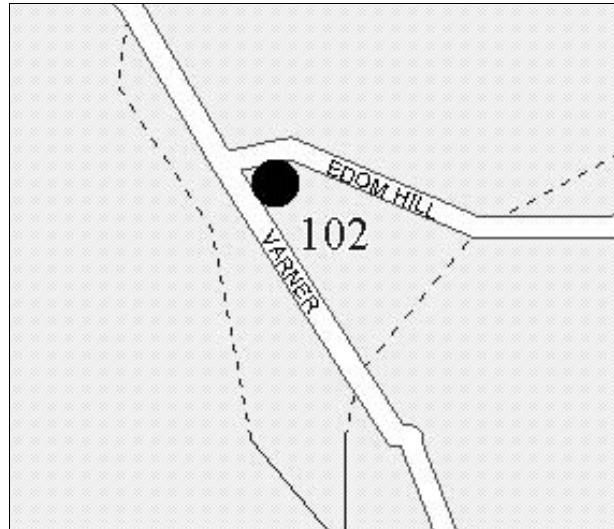
Number: **102**

Monument Description: GPS Useable: Yes
Set Cathedral City bronze disk in concrete monument

At the easterly corner of the intersection of Edom Hill Rd and Varner Rd

Approximately 20 ft from edges of pavement

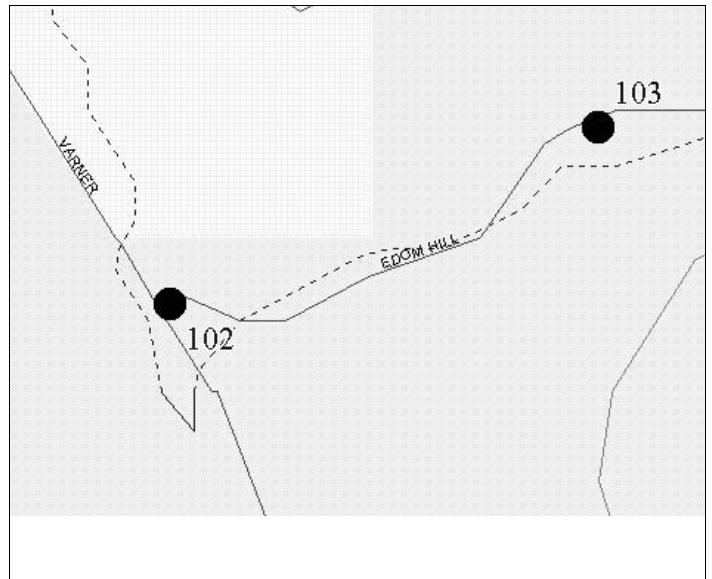
Number: **103**

Set Cathedral City bronze disk in concrete monument

On the southeasterly side of Edom Hill Rd 0.5 mi northeasterly of Varner Rd

Approximately 20 ft from edge of pavement

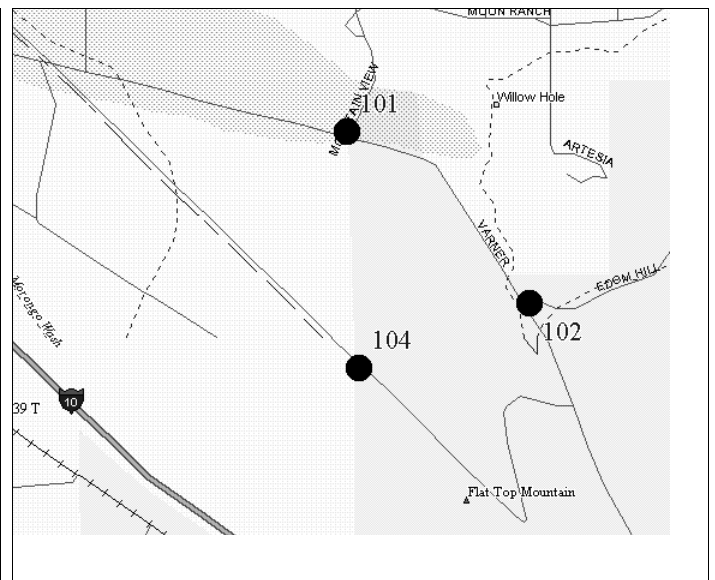
Number: **104**
Name: **FLAT TOP MT**

Monument Description: GPS Useable: Poor
Set Cathedral City bronze disk in concrete footing

In the southeasterly corner of a dirt road and slurrysealed access road, 150 ft southeasterly of a transmission tower near the corner of sections 29, 28, 33, 32 T.3S. R.5E.
Approximately 10 ft south of slurry sealed access road

Transmission lines overhead

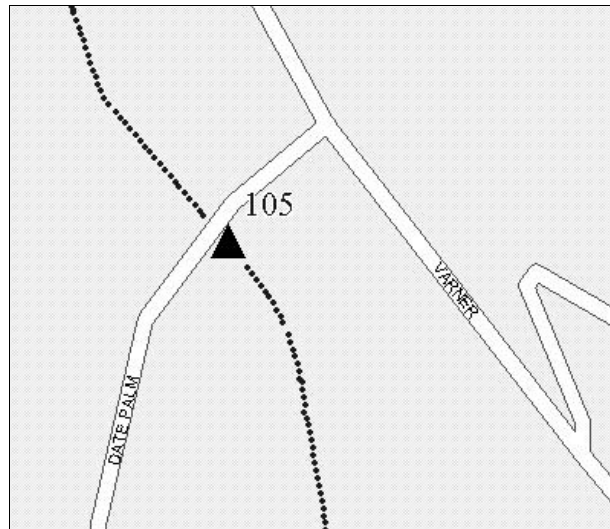
Number: **105**

Monument Description: GPS Useable: Yes
Set Cathedral City bronze disk in concrete headwall

On the easterly side of Date Palm Dr
approximately 150 ft southerly of Varner Rd

Center of concrete headwall approximately 25 ft
easterly and 5 ft below the roadway

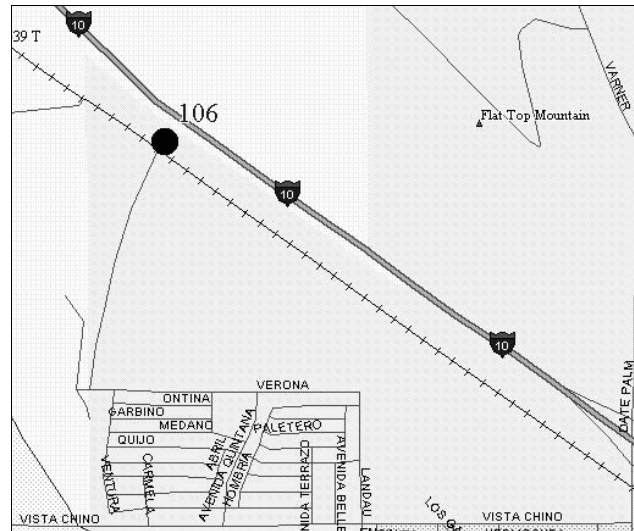
Number: **106**
Name: **SPRR MP 592.1**

Monument Description: GPS Useable: No
Set Cathedral City bronze disk in concrete monument
Stamping: 106 1996
Center Mark: Punch mark
Recovery By: RBF **Date:** Nov 1996

On the north side of the Southern Pacific Rail Road 2.5 mi. northwesterly of Date Palm Dr

At northerly prolongation of dirt trail leading to railroad 1.3 mi. northerly of Vista Chino

Trees to northeast and southwest

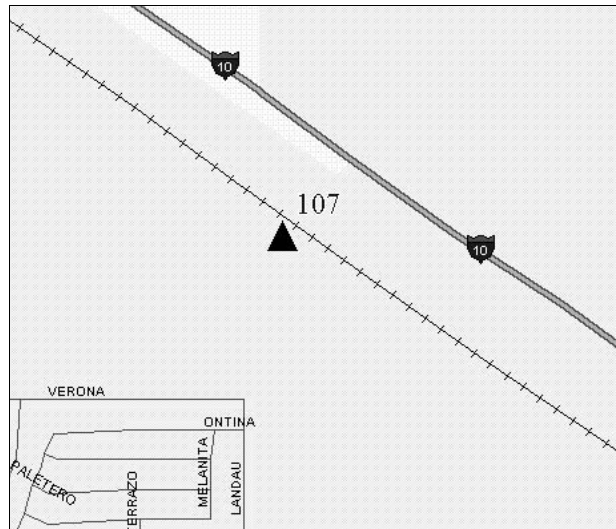
Number: **107**
Name: **SPRR MP 593.4**

Monument Description: GPS Useable: No
Set Cathedral City bronze disk in concrete footing

On the south side of the Southern Pacific Rail
Road 1.2 mi. northwesterly of Date Palm Dr

On the northwest side of signal building

Trees to northeast and southwest

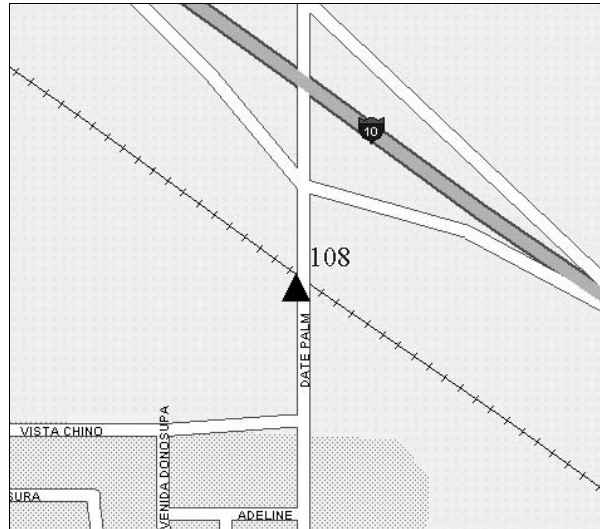
Number: **108**

Monument Description: GPS Useable: Yes
Set Cathedral City bronze disk in concrete bridge abutment

At the southwesterly corner of bridge over Southern Pacific Rail Road on Date Palm Dr

In walkway over bridge abutment approximately 500 ft north of Vista Chino Rd

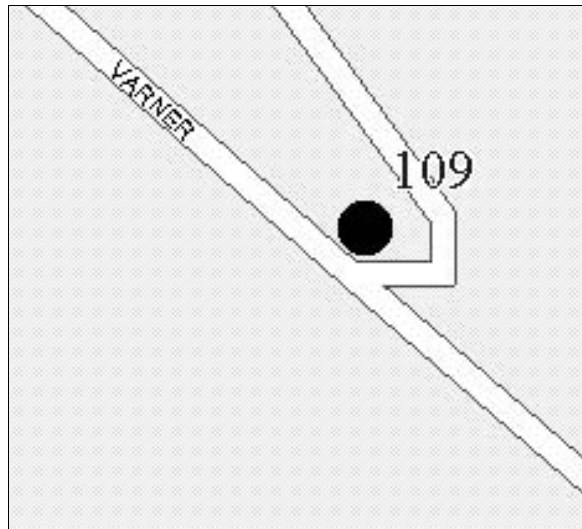
Number: **109**

Monument Description: GPS Useable: Yes
Set Cathedral City bronze disk in concrete monument

At the northwesterly corner of Varner Rd and FAA Radar Rd

Approximately 20 ft from edges of pavement and 1.1 mi southeasterly of Varner Rd

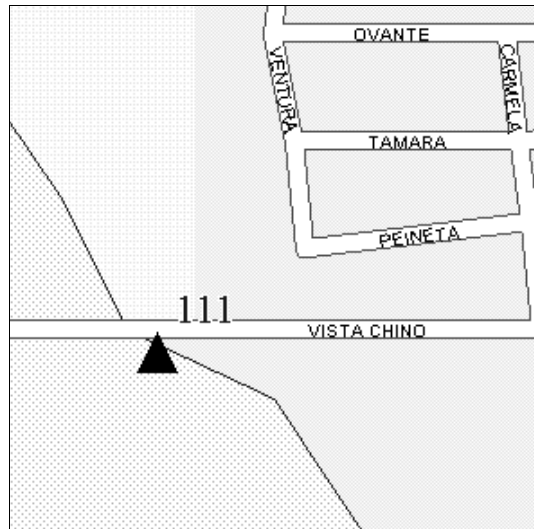
Number: **111**

Monument Description: GPS Useable: Yes
Set Cathedral City bronze disk in concrete bridge wingwall

Approximately 40 ft southeasterly of the southeasterly corner of bridge over the Whitewater River on Vista Chino

In the top of the concrete slope paving on easterly side of river southerly of Vista Chino

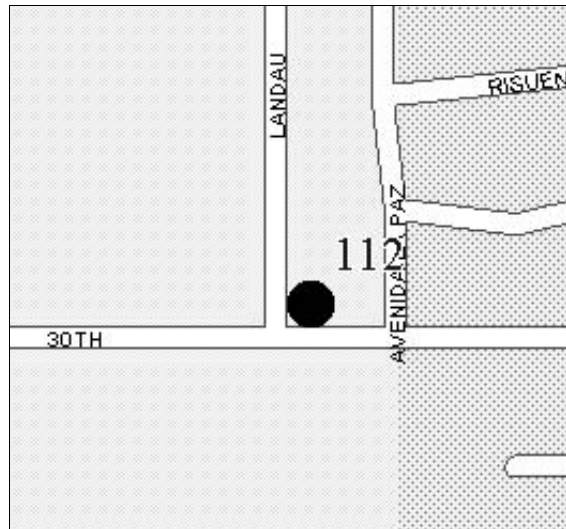
Number: **112**
Name: **LANDAU / 30TH**

Monument Description: GPS Useable: Yes
Set Cathedral City bronze disk in concrete monument
Stamping: 112 1996
Center Mark: Punch mark
Recovery By: RBF Date: Nov 1996

At the northeasterly corner of Landau Blvd and 30th Ave

Approximately 20 ft from edges of pavement

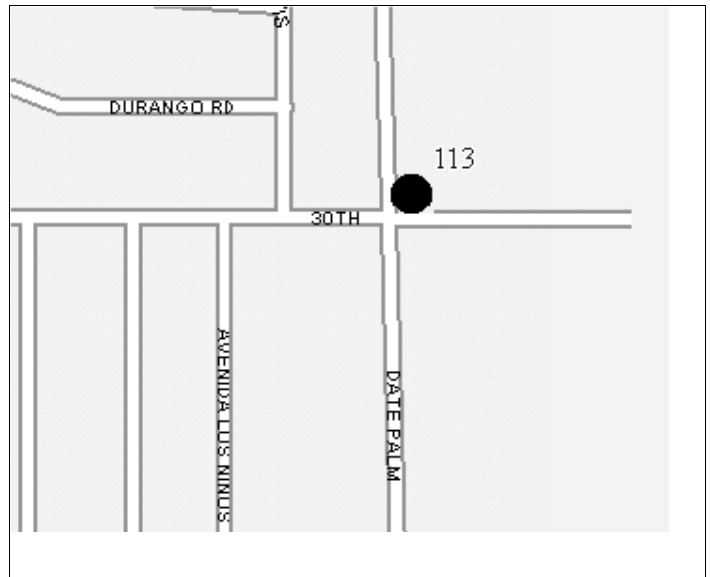
Number: **113**

Monument Description: GPS Useable: Yes
Set Cathedral City bronze disk in concrete monument

At the northeasterly corner of Date Palm Dr and 30th Ave

Approximately 20 ft from edges of pavement

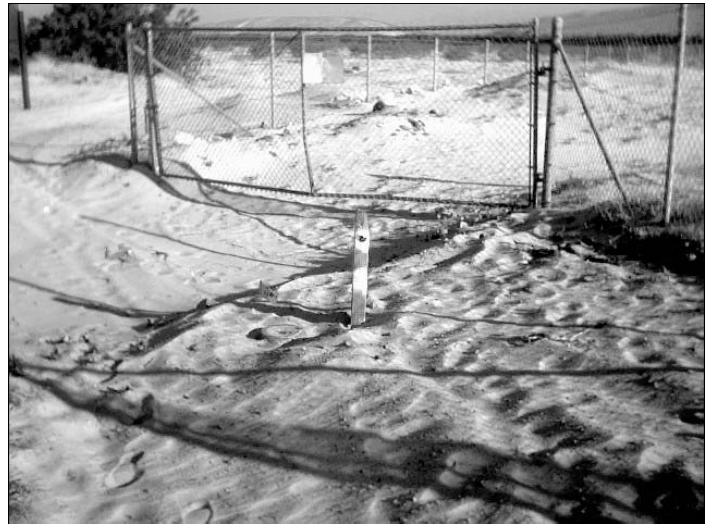
Number: **114**

Monument Description: GPS Useable: Yes
Set Cathedral City bronze disk in concrete monument

At the northeasterly corner of Davall Rd and 30th Ave

Looking Easterly

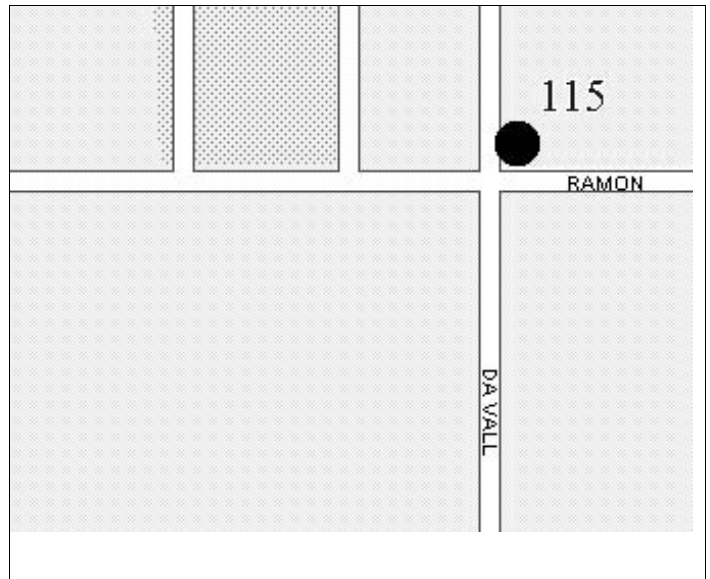
Number: **115**

Monument Description: GPS Useable: Yes
Set Cathedral City bronze disk in concrete monument
Stamping: 115 1996
Center Mark: Punch mark
Recovery By: RBF **Date:** Nov 1996

At the northeasterly corner of Davall Rd and Ramon Rd

Approximately 20 ft from edges of pavement

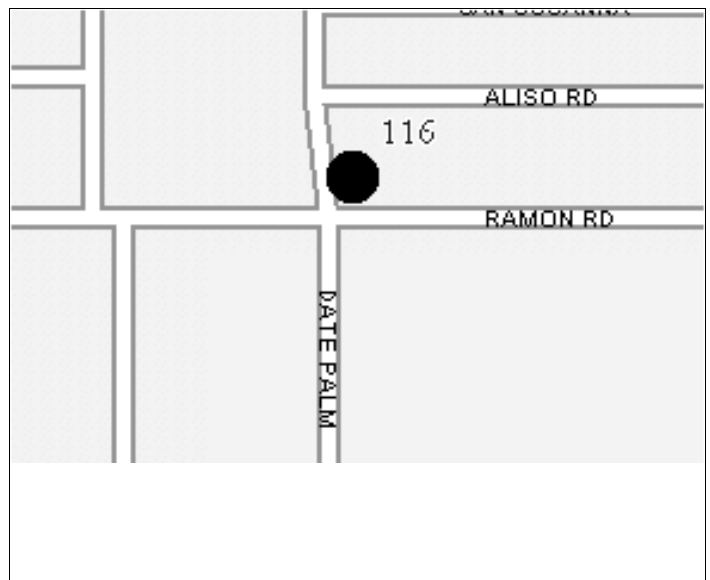
Number: **116**

Monument Description: GPS Useable: Yes
Set Cathedral City bronze disk in concrete monument

At the northeasterly corner of Date Palm Dr and Ramon Rd

Approximately 20 ft from edges of pavement

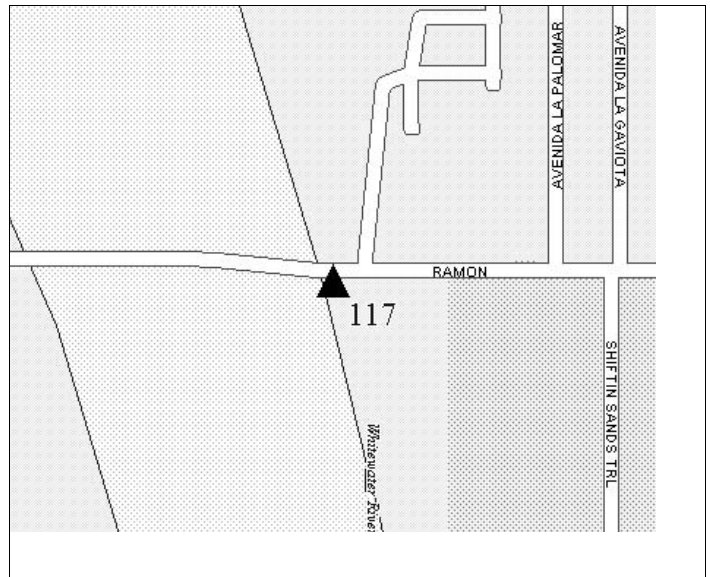
Number: **117**

Monument Description: GPS Useable: Yes
Set Cathedral City bronze disk in concrete bridge abutment

At the southeasterly corner of bridge over Whitewater River on Ramon Rd

In walkway over bridge abutment approximately 500 ft west of Landau Blvd

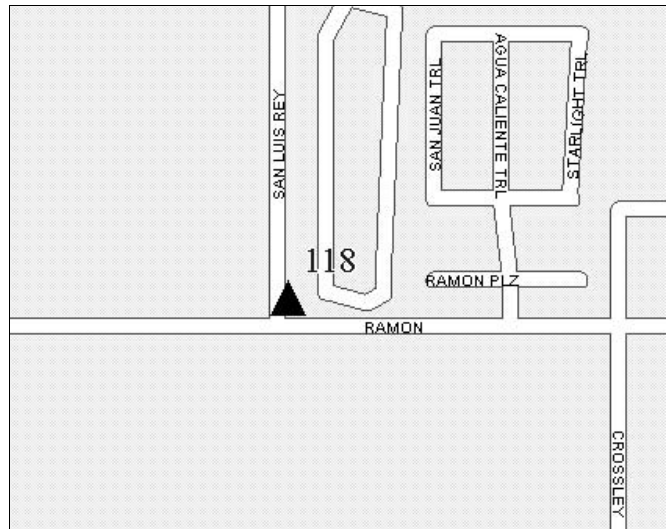
Number: **118**

Monument Description: GPS Useable: Yes
Set Cathedral City bronze disk in concrete inlet box

At the northeasterly corner of San Luis Rey Dr and Ramon Rd

In the north end of inlet box 50 ft north of Ramon Rd

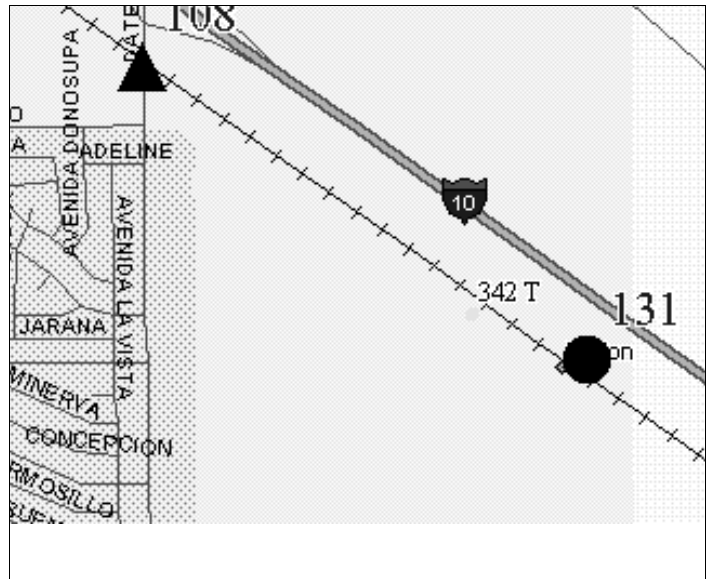
Monument Description: GPS Useable: No
Set Cathedral City bronze disk in concrete monument
Stamping: 131 1996
Center Mark: Punch mark
Recovery By: RBF **Date:** Nov 1996
Location:
On the north side of the Southern Pacific Railroad at the northerly prolongation of Da Vall Dr
Notes:
Trees to northeast and southwest
